## DPA 4 – Rocky Beach Front/Escarpment, Rockfall and Upland Slope Hazards

### Justification

#### *Rocky Beach Front and Upland Slopes*

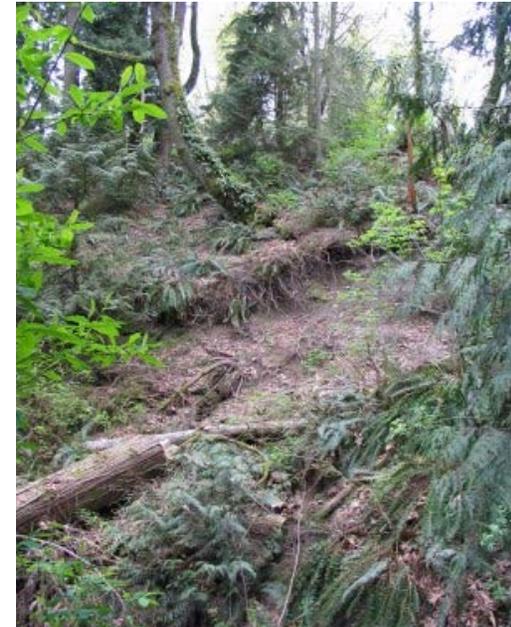
\* *Unstable soils on upland slope.*

The soils are subject to potential shallow instability, small debris landslides and to minor storm wave erosion where they are exposed along the beachfront. Creep and shallow instability in the surficial soils have been observed.

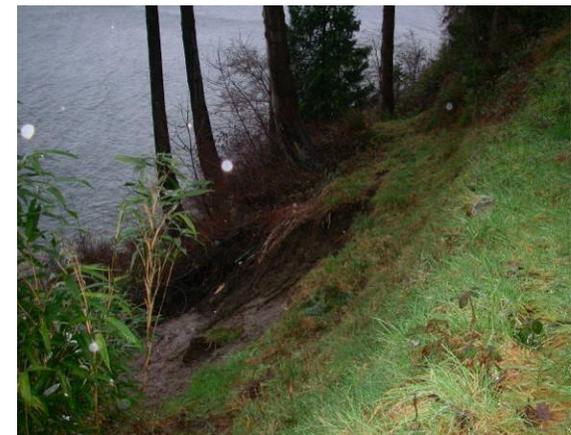
\* *Recent slope failure in Davis Bay/Selma Park after heavy rains.*
